Hydro-morphological characteristics and recent changes of a nearly pristine river system in Chilean Patagonia: The Exploradores river network

Camila Bañales-Seguel^{1,2,3}, Alejandro Salazar^{2,3,4}, Luca Mao^{2,4,5}

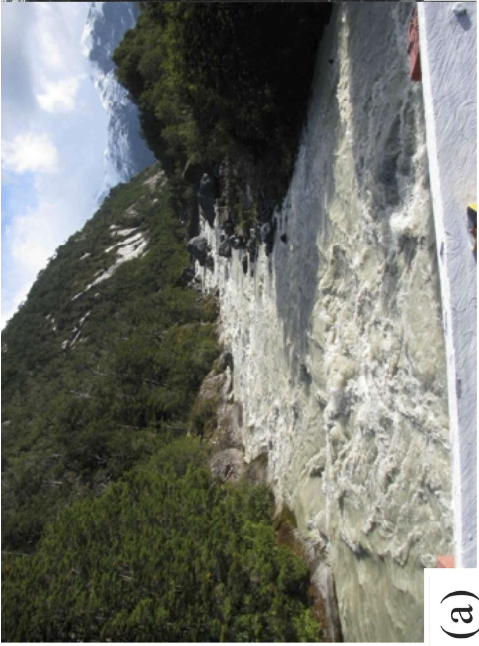
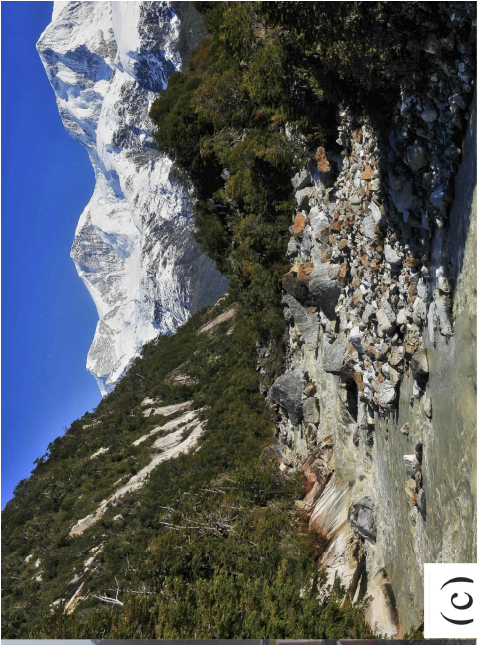
Figure 11. The Deshielo River suffered a GLOF in April 2018. The photos are taken from the bridge over the river (a) before the event (April 29, 2016), (b) during the event (April 18, 2018) and (c) after the event (April 30, 2018). Photo were taken from the point depicted on Figure 5 by (a) Camila Bañales-Seguel, (b) Ricardo Rojas, (c) Francisco Croxatto.

A more recent GLOF occurred on April 18, 2018, when the Laguna Triángulo (0.95 km²; Loriaux & Casassa, 2013) located on the southern-most branch of the Exploradores Glacier collapsed during an intense rainfall event. The discharge generated by the event inundated several tourism infrastructures located on the Exploradores road as well as the bridge constructed over the Deshielo River (see location of the Deshielo bridge in Figure 5), which drains the Exploradores Glacier basin. In its lower part, the river has a very wide floodplain (600 m) and low slope, which allow the river to diverge and braid (average braiding index about 6). During the GLOF, the peak discharge reached above bankfull levels (Figure 11) and flowed upstream the main valley towards the Bayo Lake (see Figure 5) generating up to 2 m rise in lake level (Croxatto, F., personal communication, May 3, 2018). Given that the cross-section at the bridge is about 40 m wide and 0.035 m m⁻¹ steep, considering an average water depth of about 2 m, the discharge at the time of the GLOF (assuming that the photo on Figure 11 was taken at the time of the peak) would have been at least 350 m³ s⁻¹. The Laguna Triángulo level decreased significantly and the place of moraine rupture can be seen in recent satellite images.
